## **Kona Village Apartments Fire Bremerton, WA**

# **Kona Village Apartments Fire Bremerton, WA**

**November 13, 1997**

This is Report 121 of the Major Fires Investigation Project conducted by Varley-Campbell and Associates, Inc./TriData Corporation under contract EME-97-CO-0506 to the United States Fire Administration, Federal Emergency Management Agency.

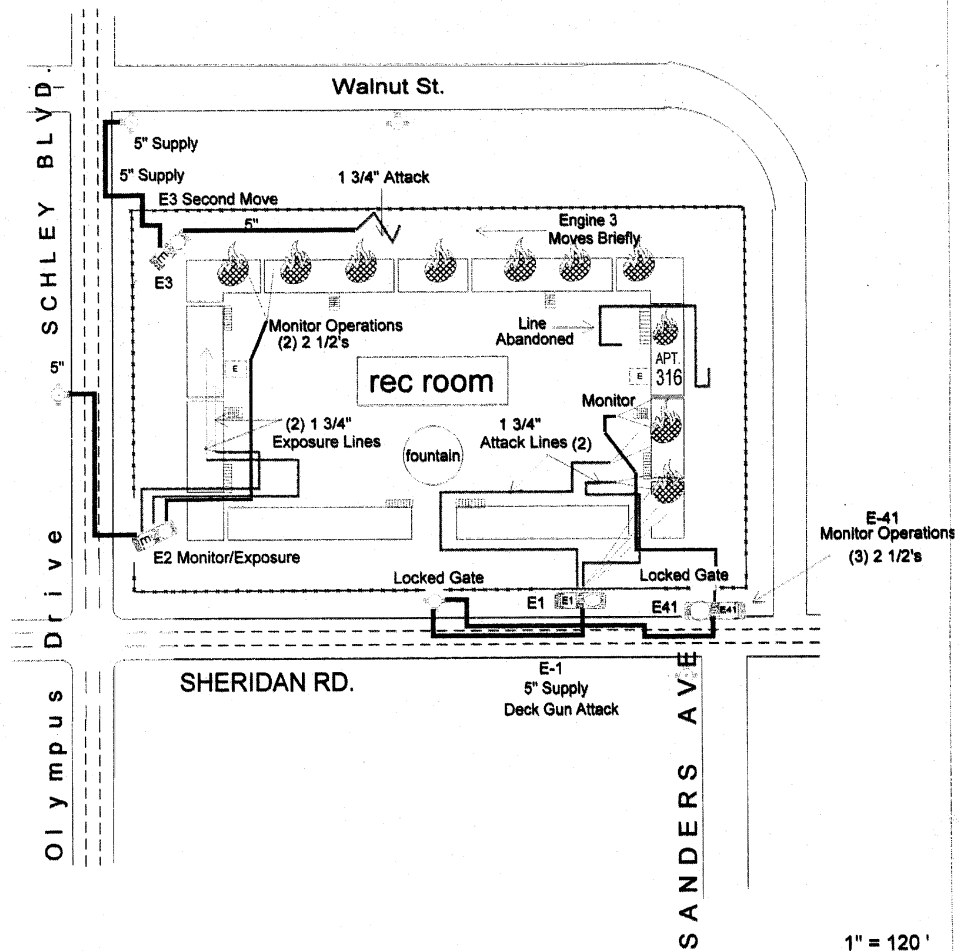
Diagram 4. Third phase of operations; cut-off fire spread, attack and extinguish

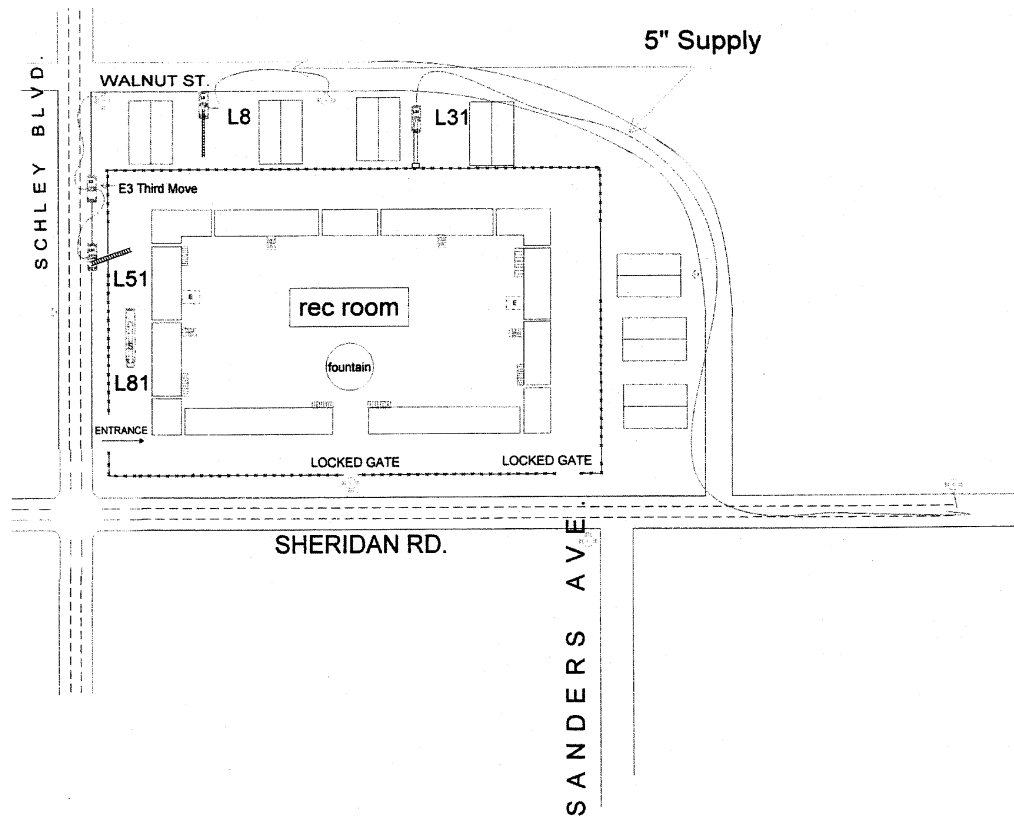
*Diagram 5. Ladder company position*

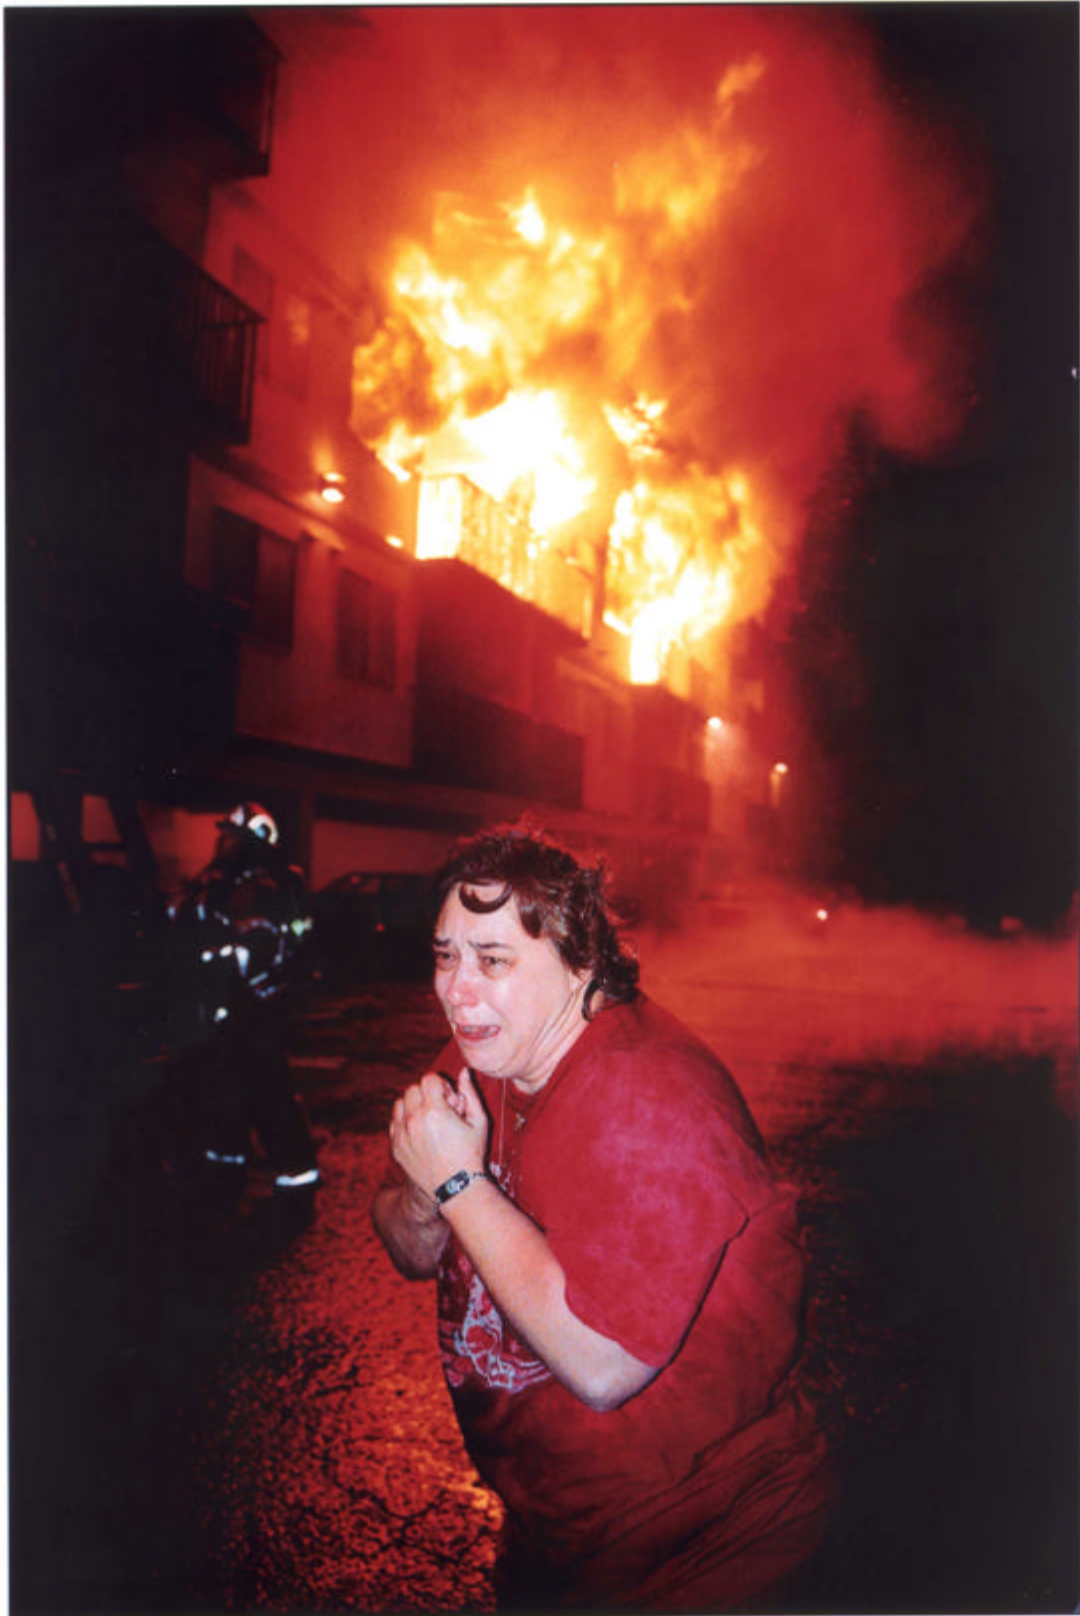
*Photo 7. A Kona Village resident just rescued from upper floor by first arriving firefighters anxiously awaits the fate of her husband. Flames in background illustrate conditions on arrival of the fire department*

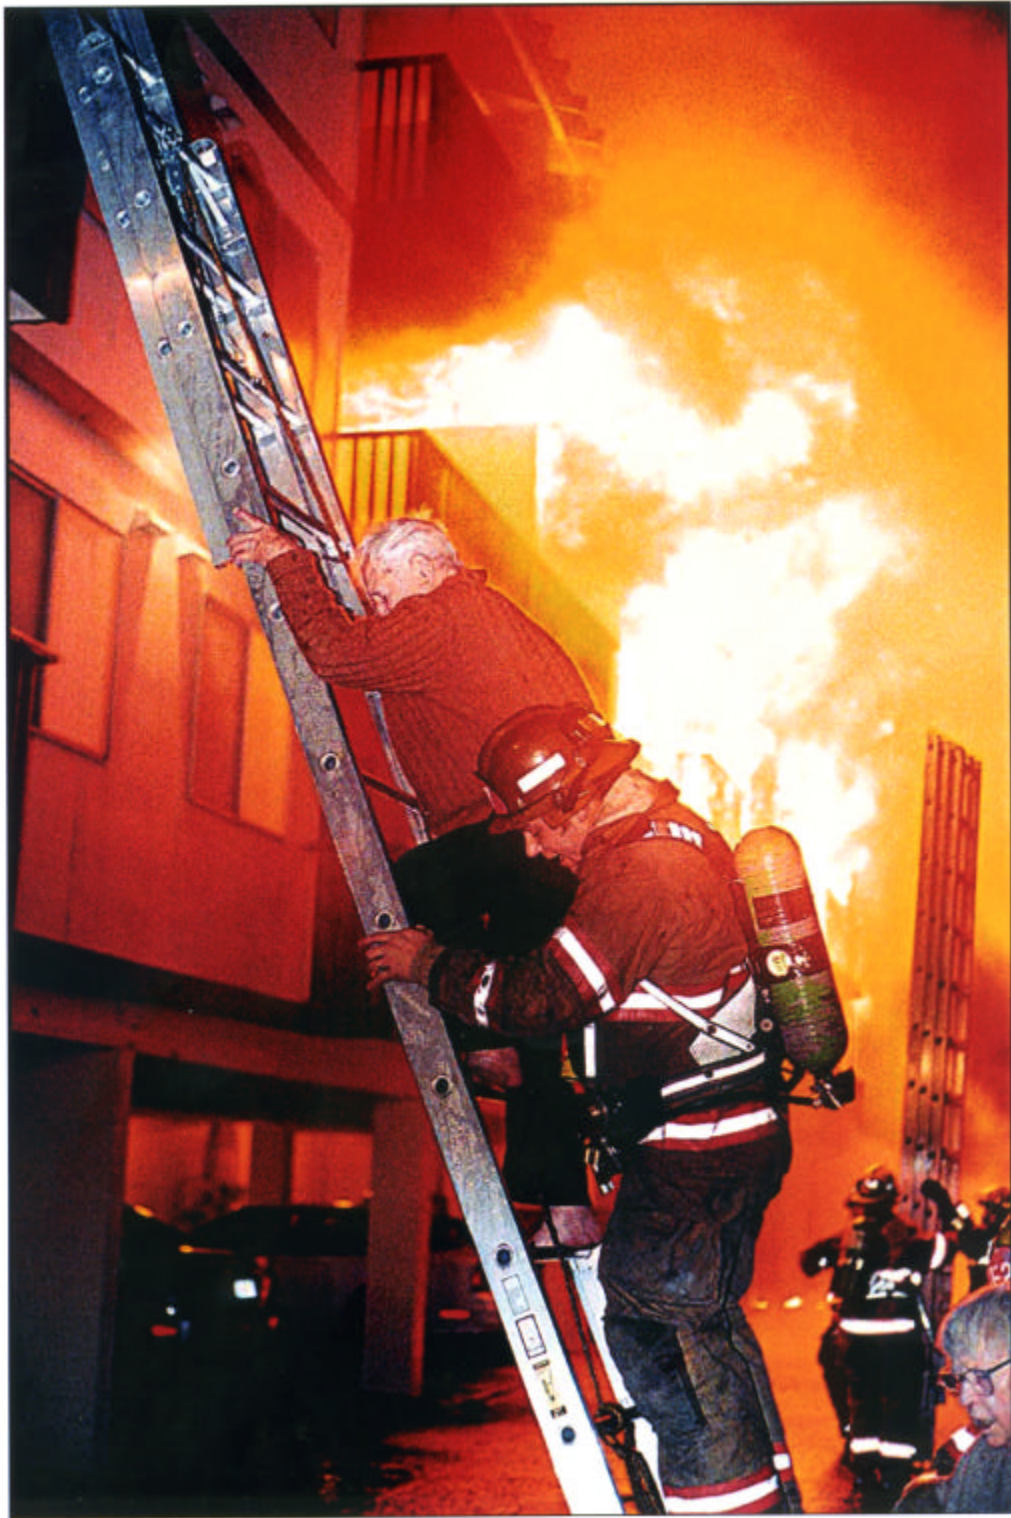
*Photo 8. Rescue of elderly tenant, spouse of woman in Photo 7, underscores problems faced by first arriving units of Bremerton Fire Department and Puget Sound Naval Shipyard Fire Department.  
(Sun Photos by Larry Stegall)*
